Microstructure and Mechanical Properties of Wear-Resistant Alloys Produced by the Laser Powder Bed Fusion Process

Kerri Horvay¹, Christopher Schade¹, Thomas Murphy¹, Corina Junghetu²

¹Hoeganaes Corporation, Cinnaminson, NJ

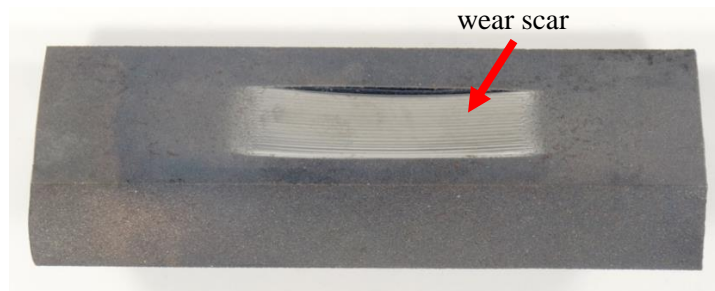
Figure 11. Image of abrasion sample after testing.

ASTM G65 abrasion test samples were heat treated according to cycle 1 (593 °C, air cool). Figure 11 shows an image of the sample after testing depicting the wear scar that formed. All alloys showed a similar wear scar. In this test the amount of volume loss correlates to the alloy's wear resistance. Figure 12 shows the volume loss of the alloys ordered from lowest to highest hardness. AW-SS had the highest volume loss while AW-S7 had the lowest. The hardness of the samples did not entirely trend with the volume loss results. Although AW-500 had a lower hardness than AW-600 it had a lower volume loss indicating better wear resistance. Both the AW-500 and AW-SPL samples had a similar volume loss at different hardness levels. The samples were only tested in one heat treatment condition. An optimized heat treatment could further improve each alloy's wear resistance.

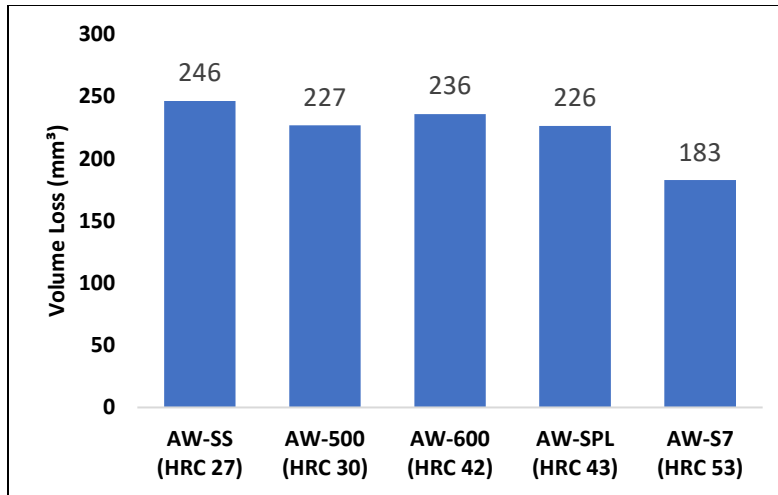
Figure 12. Volume loss results of abrasion test samples.

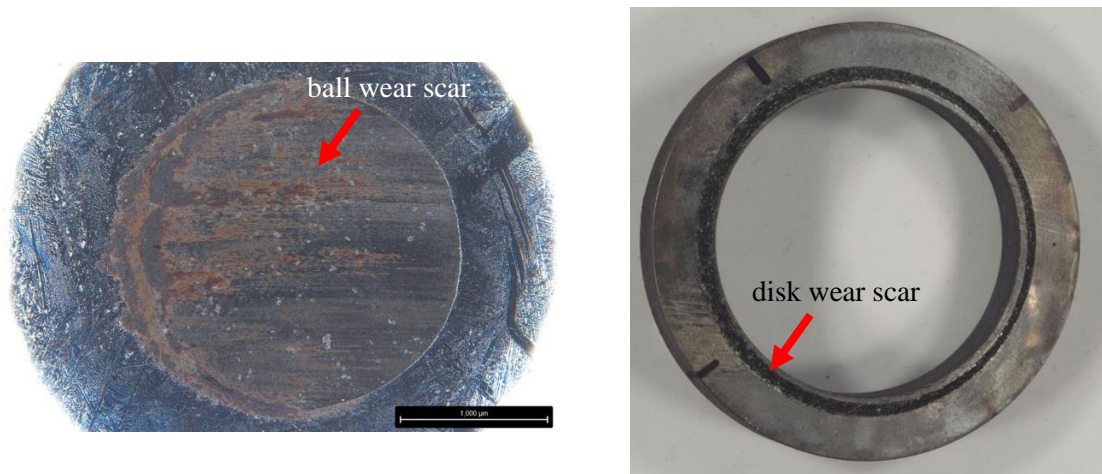
Figure 13. Images of AISI 52100 ball (left) and disk (right) after testing.

Figure 13 shows images of samples used for the ASTM G99 pin-on-disk testing. On the left there is an image showing the wear scar formed on the ball and on the right is an image showing the wear scar formed on the disk. The wear scars formed on the balls and disks were different shapes and sizes. Some of the scars appeared to be only surface scratches while others were larger with more material removed indicating a lower resistance to wear.

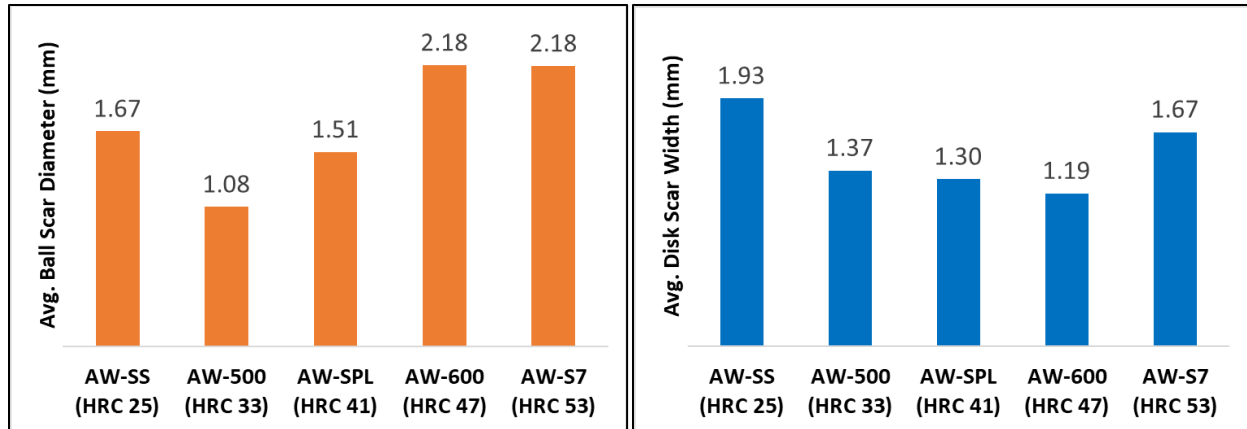
Figure 14. Summary of ball and disk wear scar measurements for AncorWear alloys.

Figure 14 shows the average size measurements of the wear scars formed on the ball and disk samples. The size of the wear scar will differ depending on how much wear one component caused on the other. AW-600 and AW-S7 caused the most wear to the ball forming a scar with a 2.18 mm diameter while AW-500 caused the least wear on the ball forming a scar with a 1.08 mm diameter. The diameter of the ball wear scars trends with the hardness of the alloys except for AW-SS. AW-600 had the smallest disk wear scar width at 1.19 mm. The AW-S7 disk wear scar was second largest of the group, which did not follow the trend of increasing hardness. The size measurement of the ball and disk wear scars did not seem to correlate visually to how much wear had occurred. The AW-S7 disk sample appeared to have the least wear of the group. The mass loss from the ball and disk may be a better indicator of wear for these samples. Only one sample was tested of each alloy, so replicate testing may also be needed to confirm the results from this test.
